# Manhole Inspection Summary

Manhole # S35CC1013MH

**Location** Address: **215 SOUTHWAY**

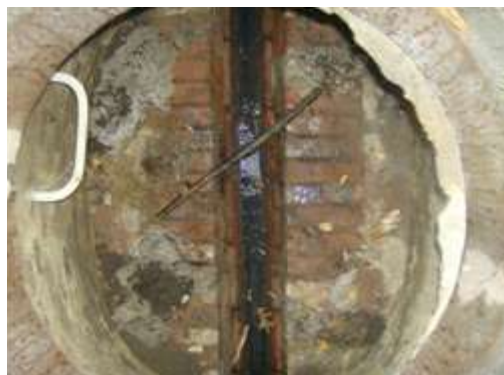
Top View

Infiltration: ☐ None ☒ **Joint** ☐ Cracks ☐ Mortar ☐ Roots ☒ **Wall**

Infiltration: ☐ None ☐ Joint ☐ Cracks ☐ Mortar ☐ Roots ☒ **Wall**

**Bench** ☒ Exists Material: **Brick** ☐ Parged ☒ **Debris** (not Condition related)

**Surcharge** ☒ **Evidence Of Surcharge** Depth: **1** (ft.) ☐ Active Surcharge Present

Evidence of surcharge - Bench debris.  
Corbel and Barrel infiltration.

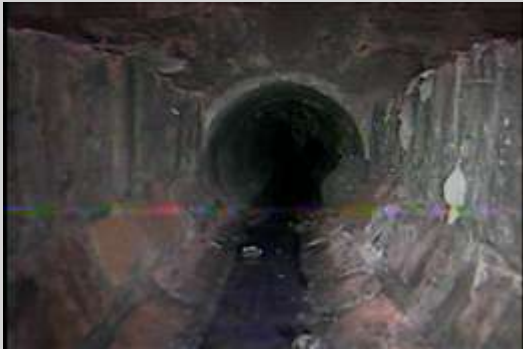
### 8 in. Circular Gravity Sewer Pipe Out @ 12 O'Clock

Infiltration: **Evidence** Pipe Seal Cond: **Roots**
